**ELIZABETH MINE SUPERFUND SITE**  
**Public Information Update**  
**June 2021**

# Elizabeth Mine Update June 2021 Background Information

# Elizabeth Mine Update June 2021

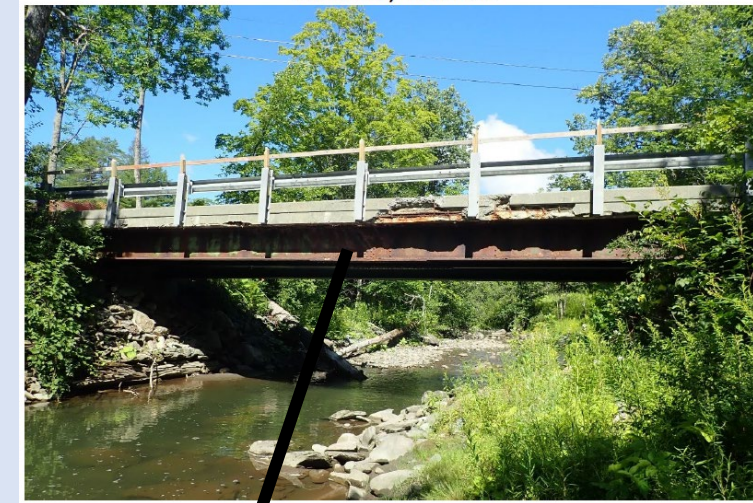
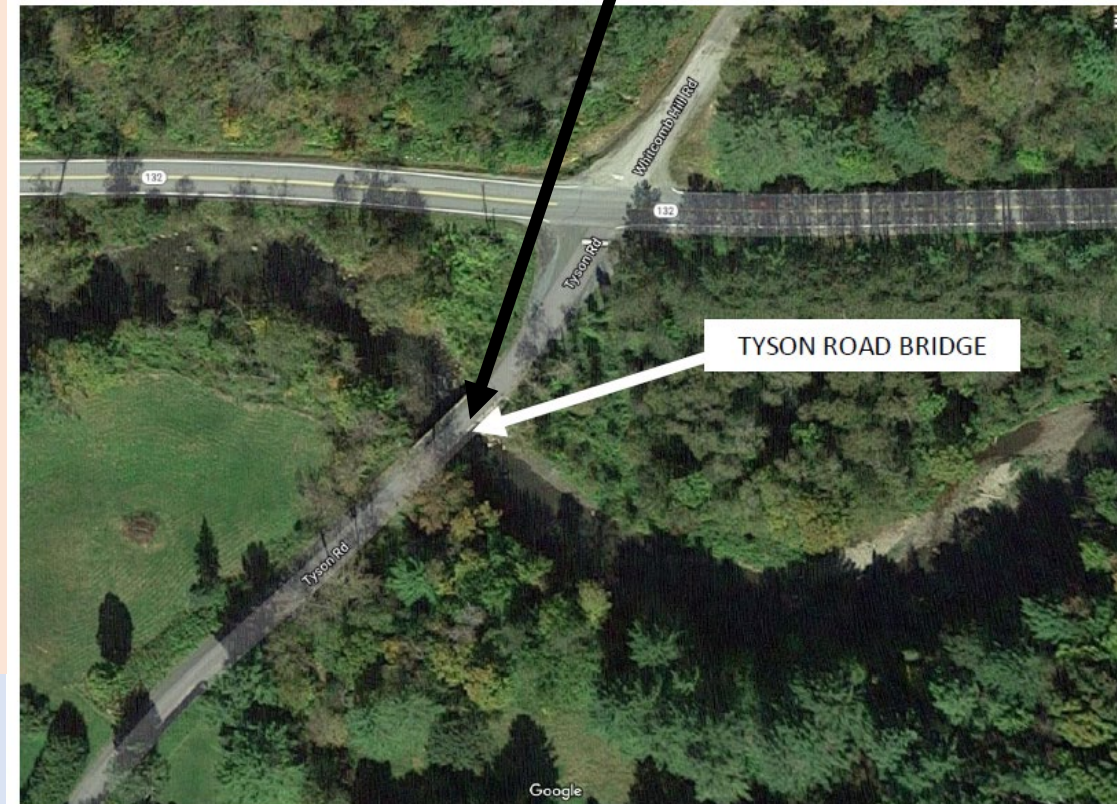
- Initial attempt to repair the deck on Tyson Bridge was initiated during 2020.
- Once the bituminous asphalt layer over the concrete bridge deck was partially removed, the bridge deck was found to have deteriorated to a degree that a simple repair was not appropriate.
- The US Army Corps of Engineers (USACE), working for EPA, collaborated with the Town of Strafford, Vtrans, VTDEC, and the site contractor, Nobis, to develop a bridge deck replacement design.
- The bridge beams were inspected by Vtrans and found to be in acceptable condition.

- Contractor mobilized on May 12, 2021.
- Existing deck removal was completed on May 20, 2021.
- Poured new concrete deck on June 2, 2021.
- Remaining work:
  - Install asphalt top layer
  - Install new asphalt approaches
  - Install new guardrail
- All work except new guardrail should be completed in June.
- Guardrail may not be available until August 2021.

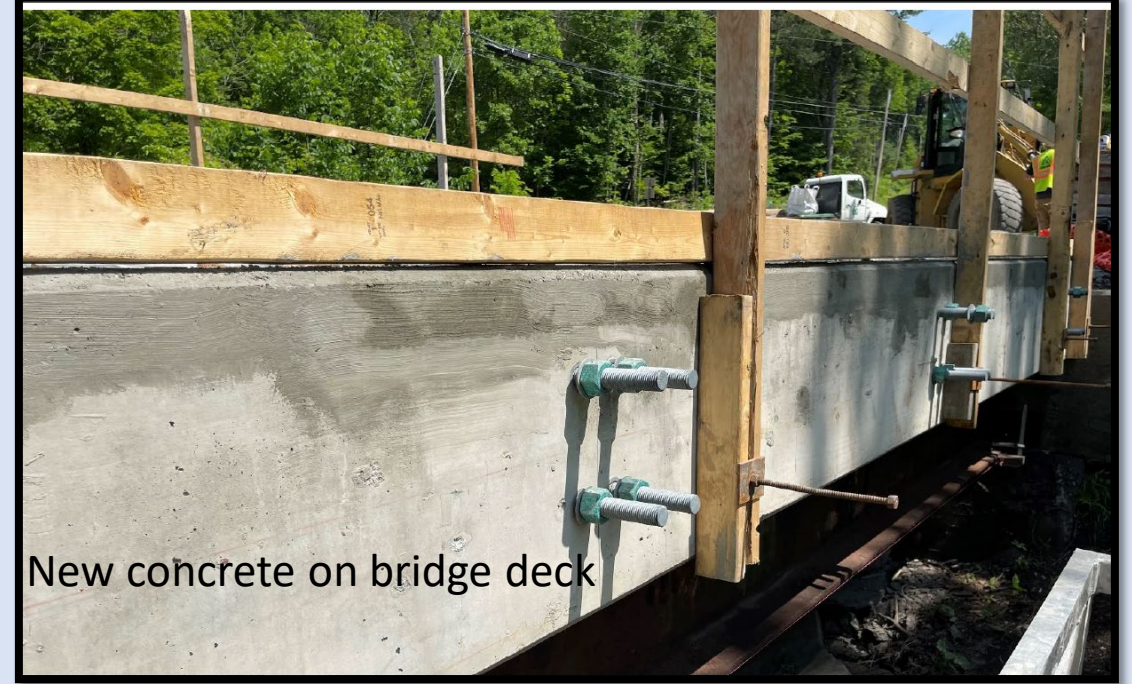
New concrete on bridge deck

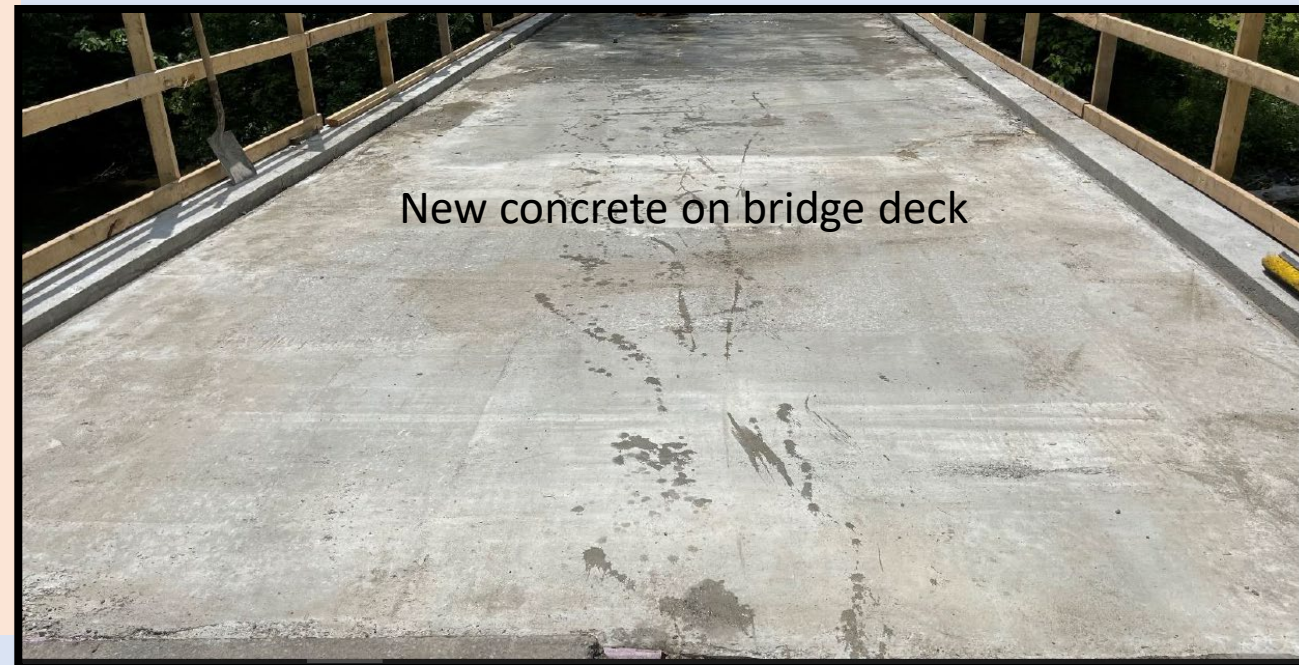
New concrete on bridge deck

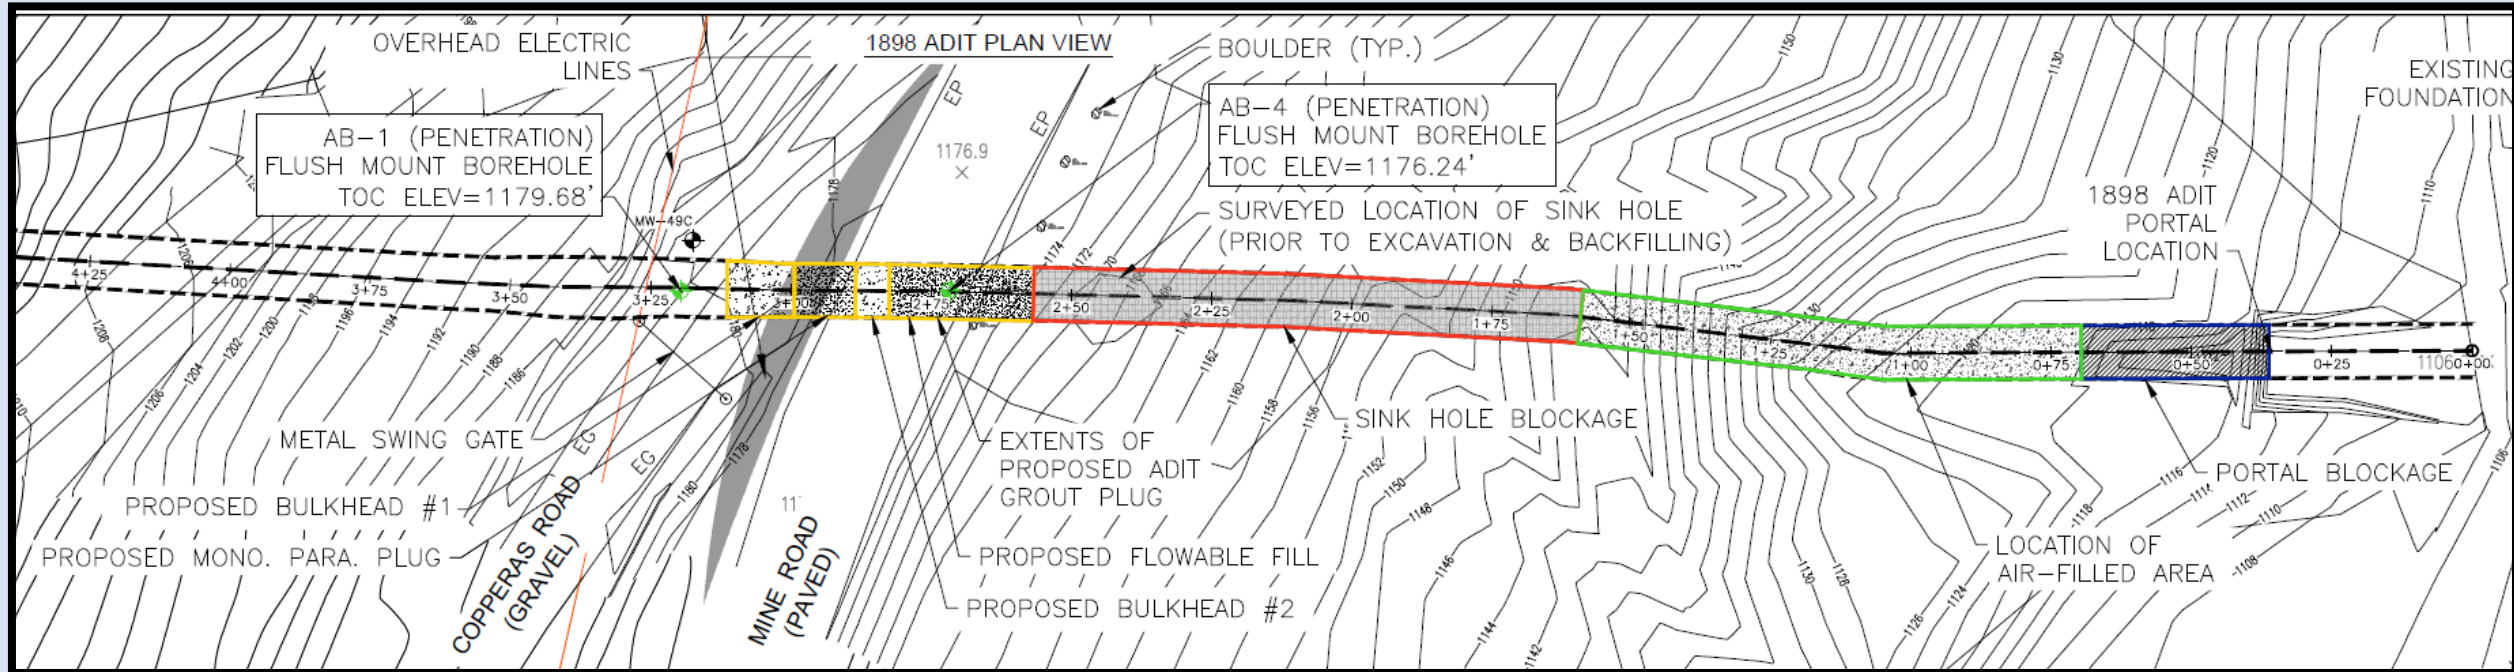
# Plan view of 1898 Adit Closure showing location of the two collapse zones (blockages)

- The 1898 Adit has two internal blockages impounding an estimated 719,000 gallons of acidic water.
- The 1898 Adit also is believed to be the cause of the sink hole that formed adjacent to Mine Road in 2018.
- A concrete plug will be installed inside the 1898 Adit beneath Mine Road to prevent a future release of the impounded water.
- The concrete plug will also reduce the potential for a future sink hole at Mine Road.

- The 1898 Closure will include 5 components with an overall length of 61 ft:
  - A 12 ft long concrete bulkhead (bulkhead #1) will be installed on the Copperas Road side of the plug to prevent water from entering the work zone and act as a seal.

- An acid resistant coating will be placed on the upgradient side bulkhead #1.
  - A second 6 ft long concrete bulkhead (bulkhead #2) will be installed on the downgradient side to create a form for the plug.

- Grout/concrete will be pumped at high pressure between the bulkheads to create the 11 ft long plug.
  - Flowable fill will be injected into the 1898 Adit downgradient of bulkhead #2 to fill the 32 ft of void space between the bulkhead and the blockage at the Sink Hole.
